Waterfront Facilities Inspection

Naval Training Center
Great Lakes, Illinois

RE: Contract N-62472-87-C-7706 - WATERFRONT FACILITIES INSPECTION

WATERFRONT FACILITIES INSPECTION
FOR THE
NAVAL TRAINING CENTER
GREAT LAKES, ILLINOIS

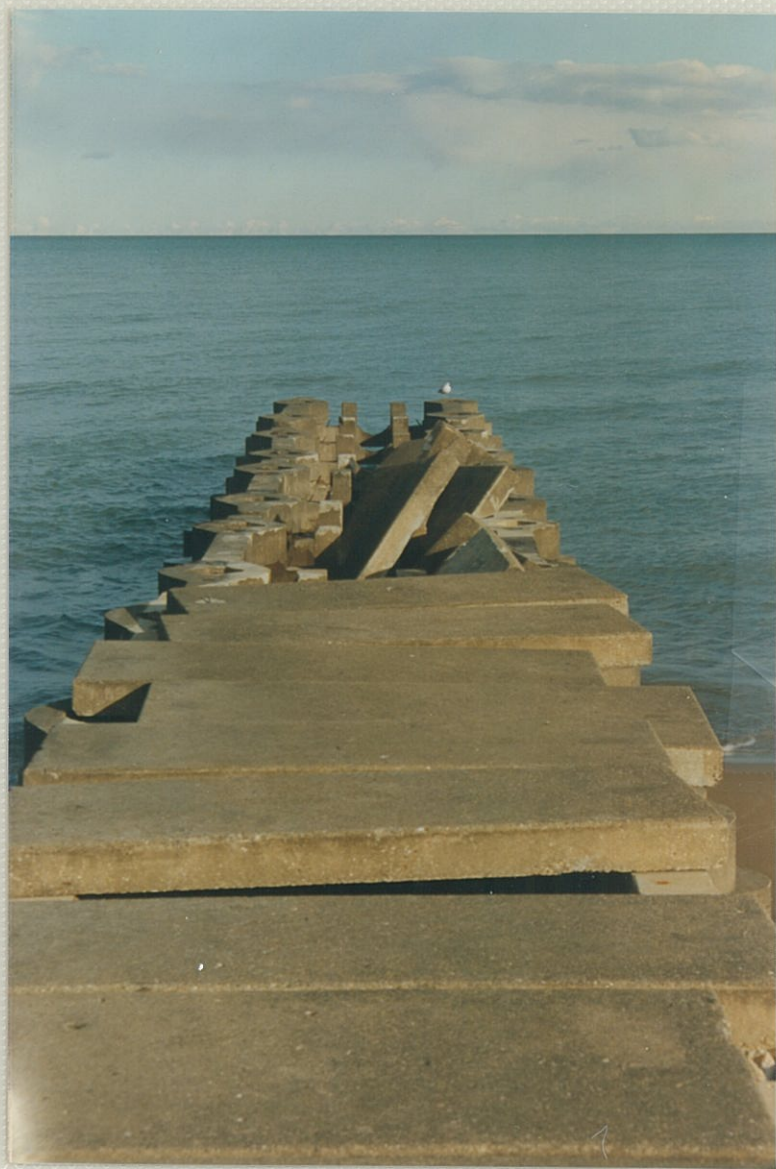
All that remains of the timber groins are two pairs of closely-spaced piles. The structures have failed in terms of structural integrity and performance.

Both concrete groins appear to serve little or no function. Therefore, repairs are not warranted. The same conclusion applies to the failed timber groins located adjacent to the FBI rifle range. The slope adjacent to the timber groins is protected from erosion by a rubble revetment that was bulldozed from the top of the slope. In the short term, this shore protection is performing satisfactorily; however, the erosion protection is hap hazard at best and will require constant attention. As discussed in the NTC high water level study (Reference 2), remedial repairs will be required at the toe of slope to protect against slope failure. Any erosion of the existing shoreline in this area should be addressed as it occurs to guard against toe failure of the slope which could result in potentially catastrophic bluff failures.

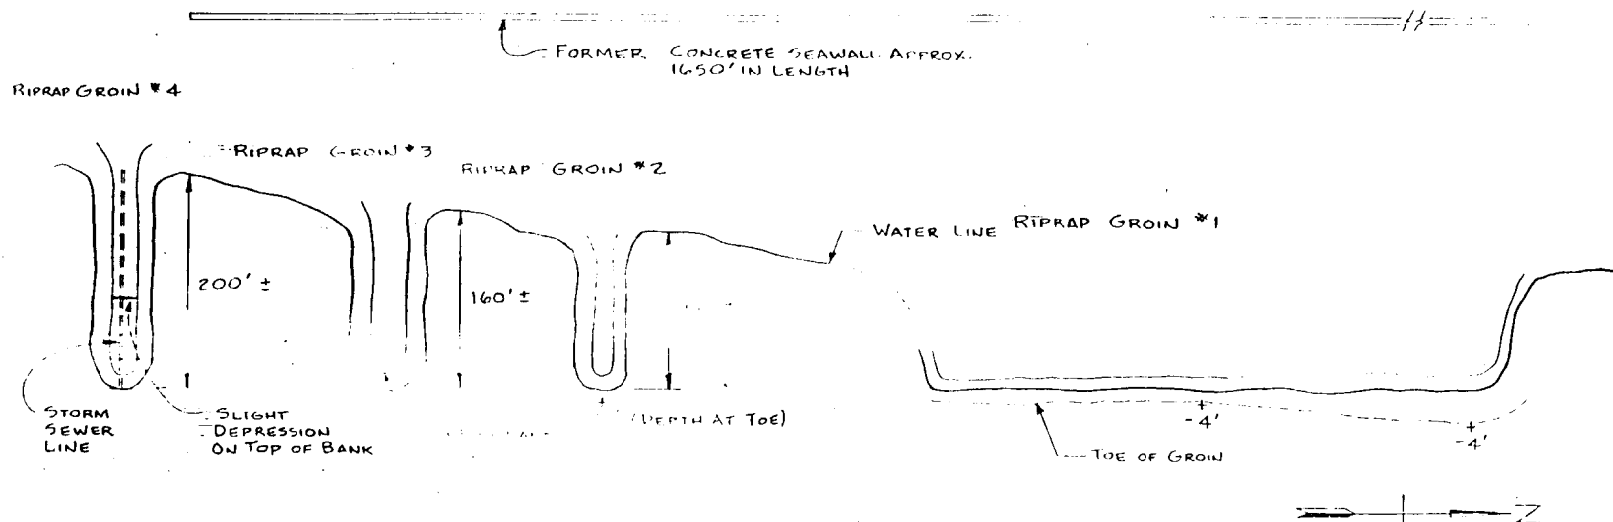
The lakefill area is protected by a rubble mound revetment constructed of concrete demolition materials (primarily slabs). Along the northern revetment (north of riprap groin No. 1), the concrete ranges in size from 0.5 to two feet thick and two to six feet in diameter. The face of the revetment is sloped at about one vertical to one horizontal. The revetment top is about 15 feet wide, approximately eight feet above normal water and about one foot above the lakefill. Erosion of topsoil has occurred at the edge of the lakefill, leaving a void about two to three feet wide between the lawn and rubble areas. The void is six to twelve inches deep at the northern revetment end, increasing to two to three feet at the southern end. Pea gravel is visible at the bottom of the void, which tends to collect driftwood and other debris (Photo 13.05)

The remainder of the riprap groin area designated Nos. 2, 3, and 4, is protected by smaller sized rubble. The rubble slabs in this area are six to eight inches thick, and about three feet in diameter, and have been placed in an armor-plate fashion. The slabs are parallel to the wave action direction. Additional protection appears to have been placed recently in the bay between groin nos. 2 and 3.
